Minnesota Historical Society
March 2007

New Fort Snelling Visitor Center

Predesign Document

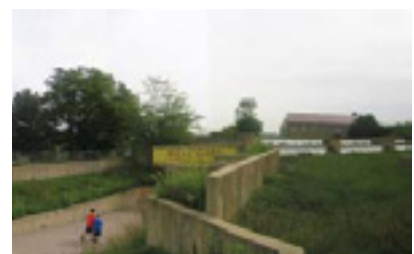
Figure 1.1.3 Current Visitor Center

To achieve these goals, the Minnesota Historical Society analyzed the current Visitor Center (Figure 1.1.3) and found the facility to be underutilized, inefficient and inadequate in its handling of visitor needs related to shopping, food, rest areas and basic site entrance visibility. More importantly, the subterranean building has significant water damage and moisture infiltration issues for which there are no permanent remedies, only temporary and expensive measures.

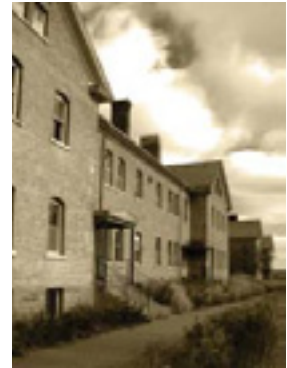
Figure 1.2.1 Cavalry Barracks

There is now a broad consensus for action. Buildings and grounds (Figure 1.2.2) that show signs of heavy visitor use need modernization. Historic structures (Figure 1.2.1) that are empty and decaying need repair and restoration. Attendance has not kept pace with the remarkable growth in the Twin Cities area. Historic Fort Snelling needs to regain its role as a major educational and cultural attraction that meets the needs of people today and in the future.

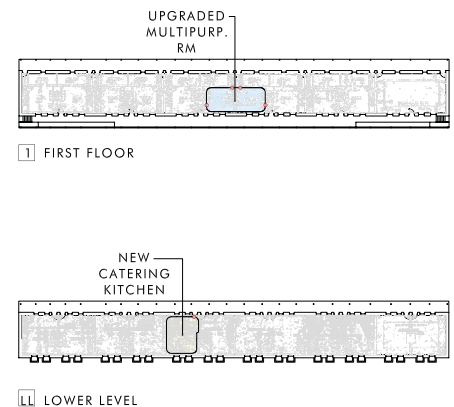
Figure 1.6.2 Officer's Quarters

The Officer's Quarters (Figure 1.6.2) will be remodeled to serve the educational and food service needs of the Historic Fort. The scope of the work will include electrical upgrades to an existing multipurpose room, a new catering kitchen and new mechanical/electrical systems.

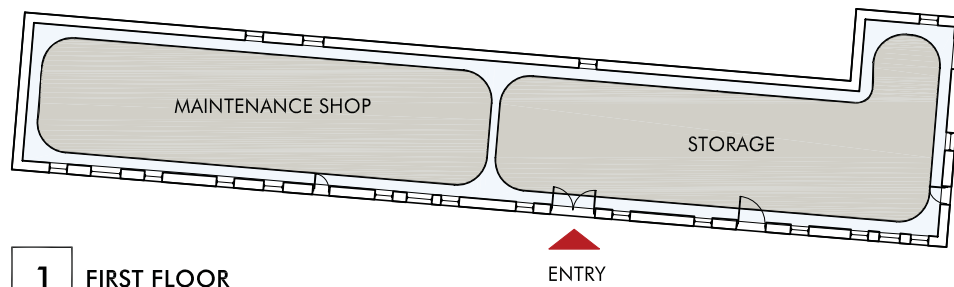
4.2 Diagrams - Ordnance Building (22)

Available GSF @ Building 22 = 4,470 GSF

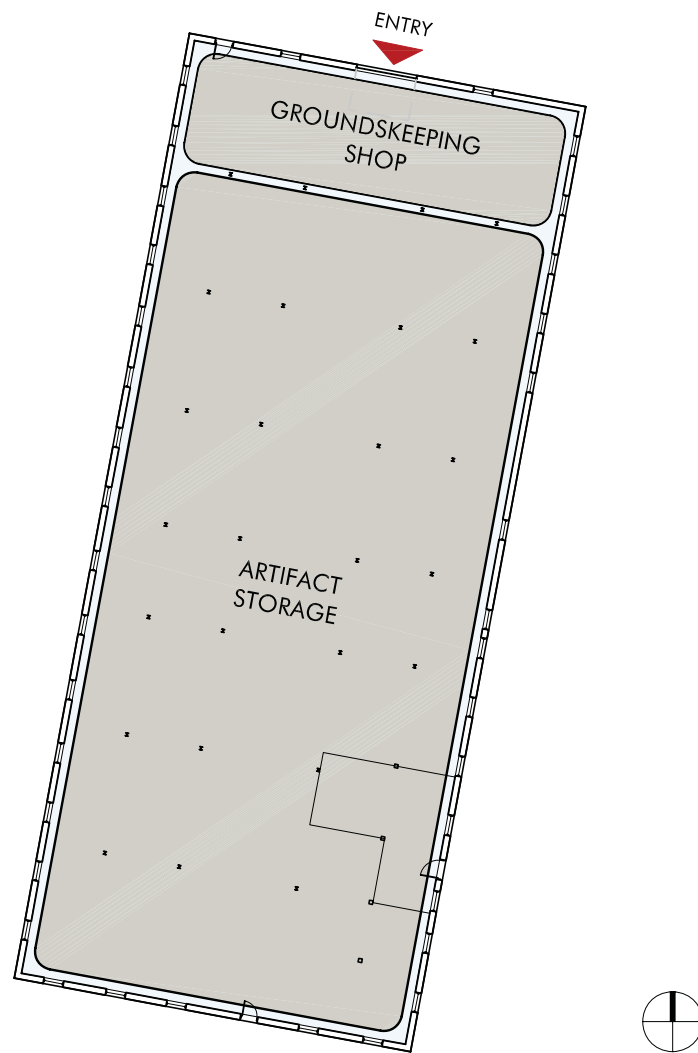
4.2 Diagrams - Cavalry Stables (Building 30)

Available GSF @ Building 30 = 12,623 GSF (including loft)
